Report No. SFIM -AEC-ET-CR-98020 FINAL REPORT

Replacing or Retrofitting Oil/Water Separators A Case Study at Fort Lee, Virginia

July 1998 Contract No. DACA31-96-D-0082 Delivery Order No. 0001

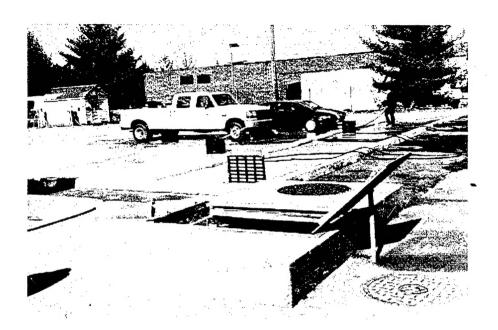
The study team observed that each of the new OWS with coalescing tube packs at Ft. Lee, were designed and equipped with small (1ft x 2ft) manways (hatches) on top for access to the internal chamber (see Photo 3-1). Because of the relatively small size of these hatches, it was virtually impossible to adequately access the central chamber and to pull out the coalescing tube packs from these OWS either for study or routine purposes. On the other hand, as indicated in Photo 3-2, the TMP's retrofitted OWS had large metal door panels, allowing easy access into the central chamber for installation and removal of the coalescing tube pack assemblies.

**Photo 3-1.** Pre-constructed OWS installed at a new motor pool washrack location. All the new OWS were equipped with small manways, inhibiting access to the internal chamber and removal of the coalescing tube packs.

Construction of OWS with coalescing media must include large enough openings to allow for complete access to and removal of the coalescing media assembly or components. The 1'x 2' manways are not adequate for this purpose.

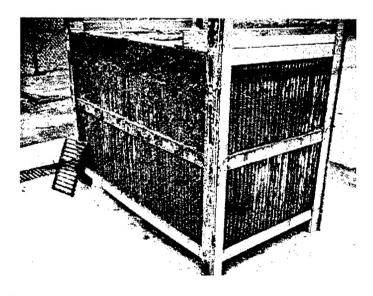
**Photo 3-2.** OWS at TMP site with its door panels open. All the retrofitted OWS were equipped with similar door panels, allowing easy access to the coalescing tube packs.

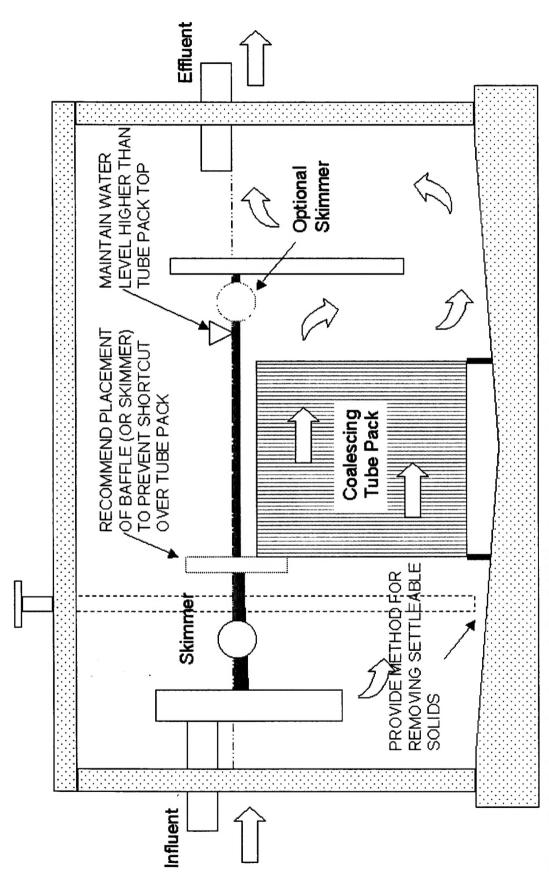
The coalescing tube pack assemblies appeared to be installed differently in the two separators chosen for this study. Figure 3-1 shows the intended design of the retrofitted OWS. In the POV washrack separator, the top of the tube pack was about 4 inches below the water surface, allowing wastewater flowing directly from the influent pipe to travel over the pack rather than through it. That by-pass flow negated the purpose of the retrofit. In the TMP separator, the top of the tube pack was about 4 inches above the water surface, resulting in trapped oil and debris inside and between the coalescing tubes.

Figure 3-1. Schematic of the OWS retrofitted with AFL coalescing tube pack at the POV site. The water level was found to be 4 inches higher than the top of the tube pack.
